Slope Stability Investigation Portal Pad

SLOPE STABILITY INVESTIGATION
PORTAL PADS AND PORTAL ACCESS ROADS
GENWAL COAL MINE
HUNTINGTON, UTAH

JOB NO. 152

November 27, 1982

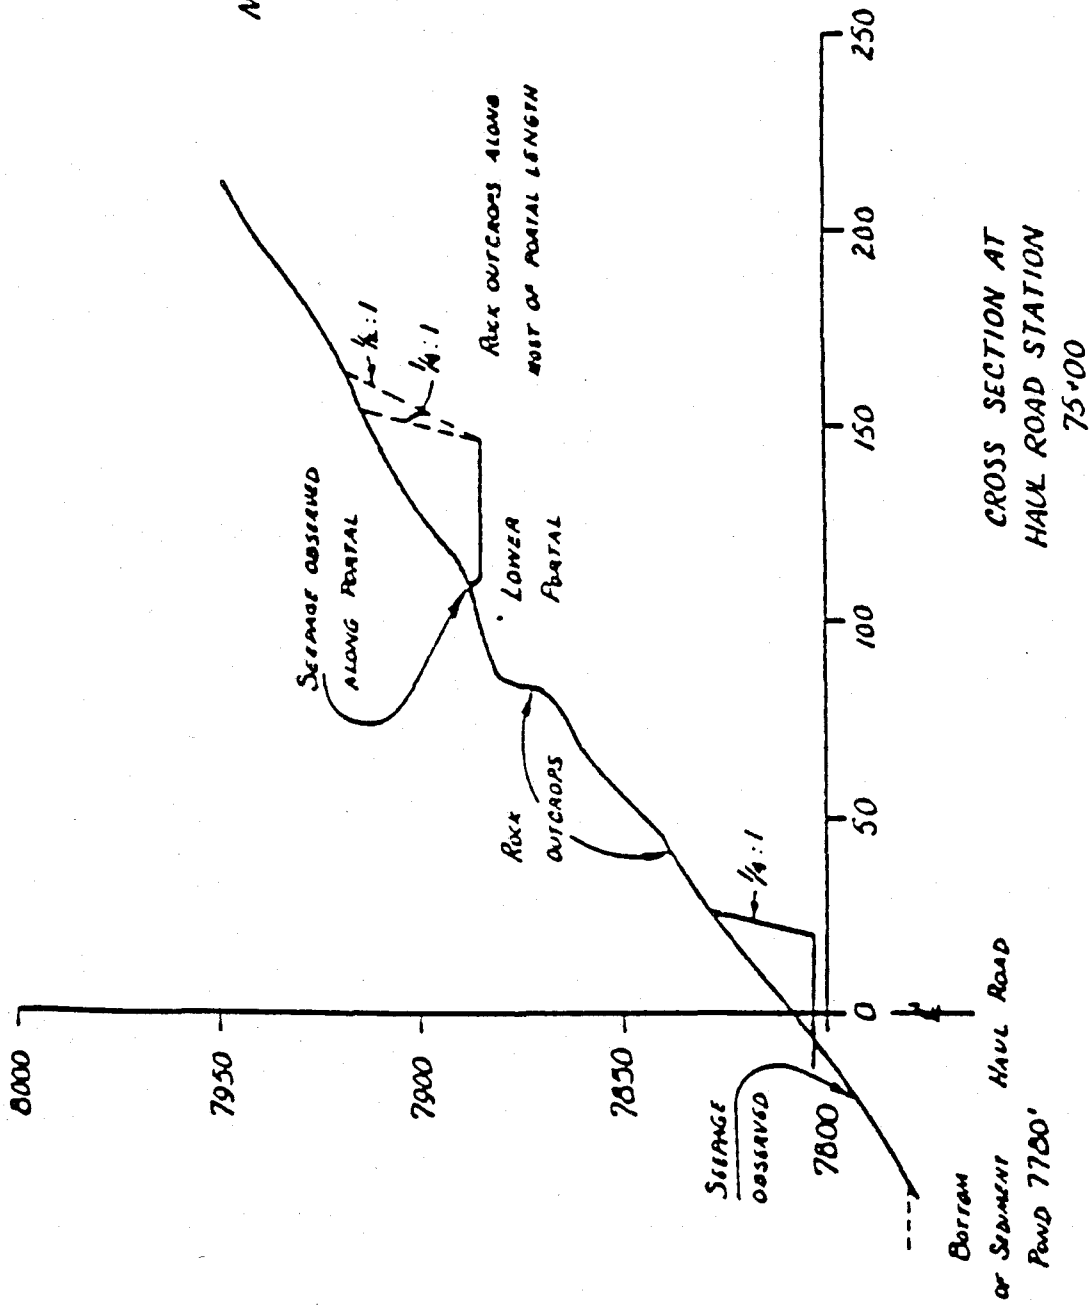
CROSS SECTION AT HAUL ROAD STATION 75+00

Cut slope profiles for four different locations are shown on Figures 2 through 5. These profiles indicate typical surface and subsurface conditions that may be expected along the proposed alignments. The profiles also show some of the problems associated with flatter excavations such as 1:1 cut slopes. As shown on Figures 4 and 5, a 1:1 cut slope could undercut the upper access road. The flatter slopes will also unnecessarily scar the hillside, and create large erosion paths. Flatter slopes will also increase the cost of construction. We, therefore, do not recommend cut slopes flatter than $\frac{1}{2}$:1, except under the conditions outlined in our recommendations above.

<u>Type of Material</u>	<u>Cut Slope (H:V)</u>
Competent Bedrock	$\frac{1}{2}$:1 to vertical
Fractured Bedrock	$\frac{1}{2}$:1
Surficial Deposits less than 4 feet deep (area 2 type)	1:1
Surficial Deposits greater than 4 feet deep (area 3 type)	2:1

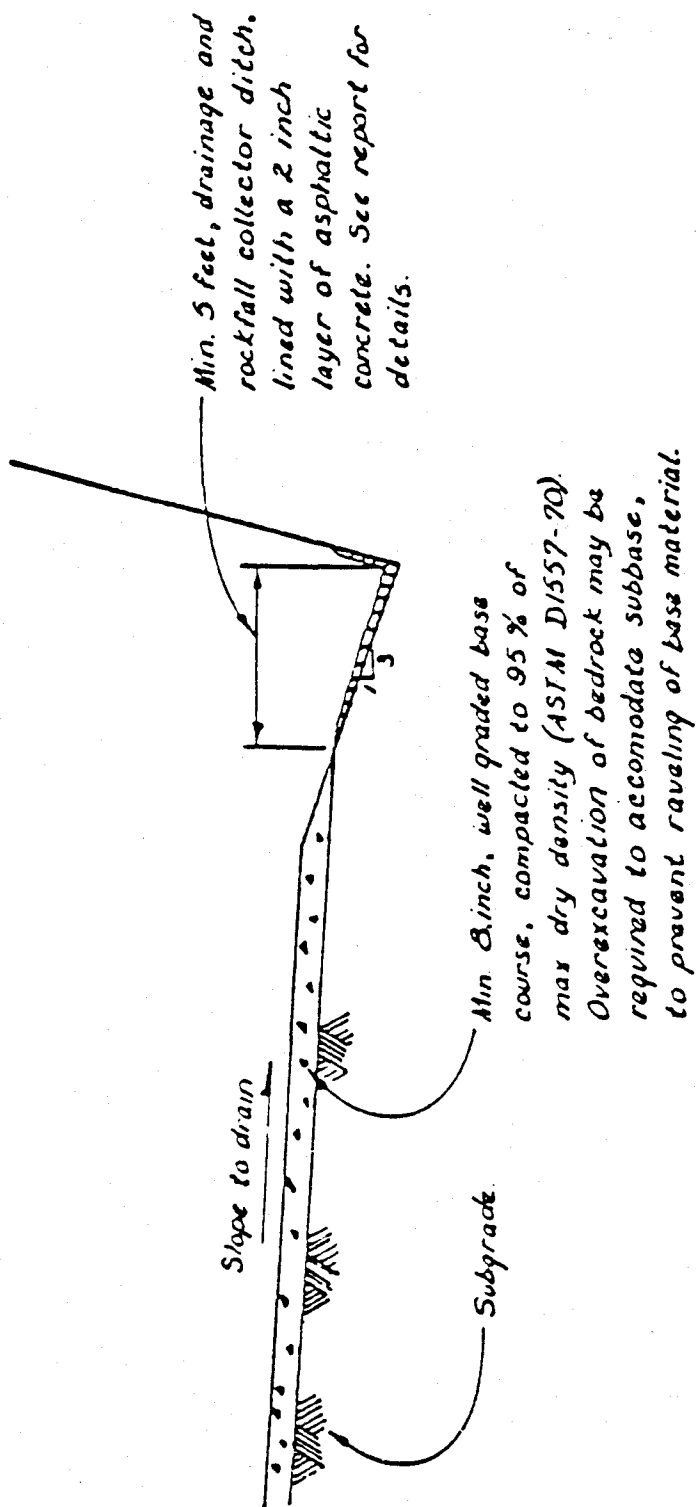
PROPOSED DRAINAGE AND
ROCKFALL
COLLECTOR DITCH

Control of surface runoff and rock falls from higher elevations, in our opinion, are the two most critical factors to be incorporated in the design and construction of the proposed facilities. Uncontrolled surface runoff will saturate surficial deposits, particularly in the areas of shallow bedrock, and will cause major slides (or mud flows) in these areas. These slides not only would delay the mine operations, but could cause major damage to men and equipment. The results of our "sliding block" slope stability analyses, which confirms our opinion, are presented on Figure 7. Rock falls, on the other hand, are unpredictable. Rock fall

could occur any time of the year due to weathering of the overhanging cliffs, and erosive forces causing the stranded rocks to loosen and roll downward. Both problems, in our opinion, can be minimized by providing a drainage (or rock fall ditch) as illustrated below. Details of the ditch construction are presented on Figure 6.

- (1) The construction activities will unavoidably alter and block the natural drainage paths along the proposed alignments. We recommend that culverts or other drainage means be provided for these areas.
- (2) The roadway should be graded toward the drainage (or rock fall) ditch to prevent ponding of water in the roadway.

- (3) The drainage ditch should be paved or properly lined with a suitable material to prevent penetration of water into the subsoils or surficial deposits. Where the roadway is underlain by claystone or impervious sandstone, ditch lining will not be required.
- (4) The excavated material should not be dumped over the downhill side of the cuts as this will lower the stability of the hillside.
- (5) The drainage ditch should be cleaned and maintained periodically to insure that the system remains functional at all times.
- (6) The natural soil cover and vegetation should be protected as much as possible to prevent erosion.

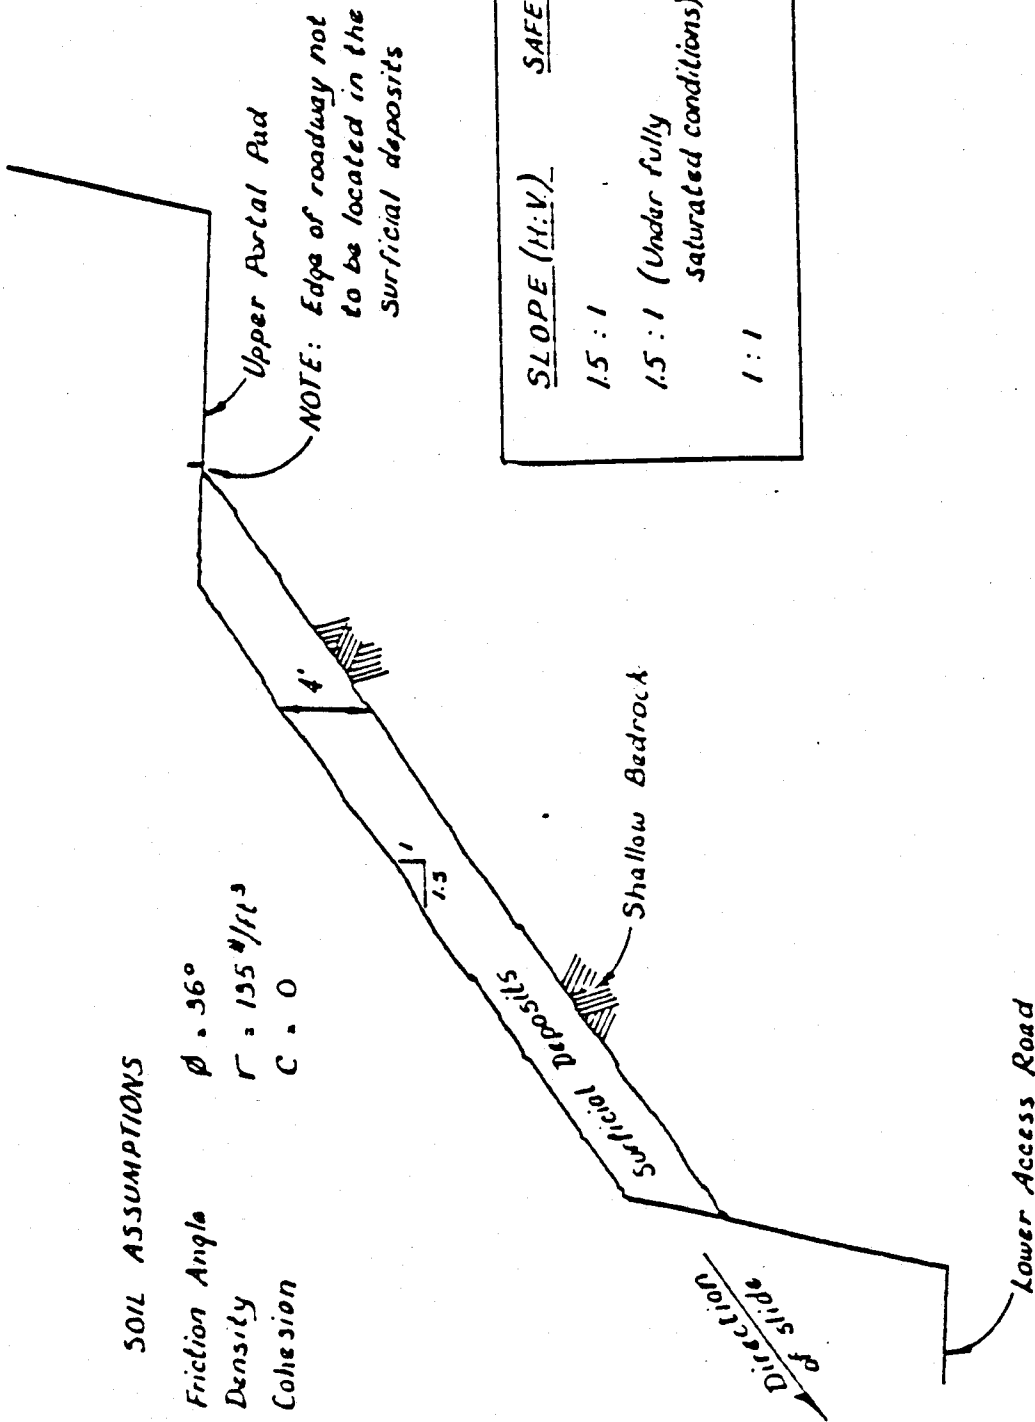
SLIDING BLOCK OR "MUDFLOW" STABILITY ANALYSIS

SLOPE (H:V)	SAFETY FACTOR
1.5 : 1	1.10
1.5 : 1 (Under fully saturated conditions)	0.64
1 : 1	0.72
